Engineering News-Record

Contents for March 16, 1933

VOLUME 110, NUMBER 11

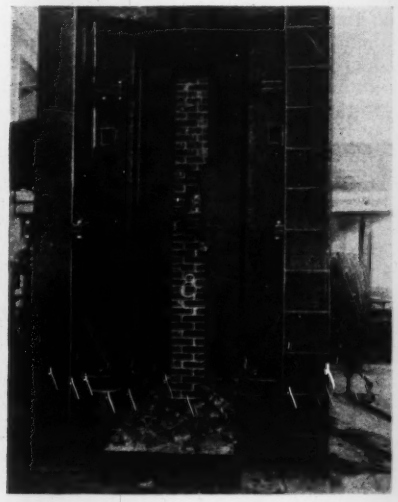
While the lateral ties did not seem to have a marked effect upon the strength of the columns, the type of failure was materially affected, as shown in the accompanying illustration. Before the maximum load was reached on any of the columns tested, cracking sounds were heard, and inspection revealed that vertical cracks had appeared. These cracks followed the vertical joints and fractured the brick along the line of cracking. The reinforced-brick columns showed a much greater toughness before failure occurred than did the plain columns. The latter collapsed completely under load. This series of tests would seem to indicate that reinforced-brick columns may be so constructed that they give very high strength and ample warning of impending failure.

Comparison of failures of reinforced-brick columns with and without lateral ties. The use of ties did not increase the strength, but it did obviate complete collapse, as shown at the left.

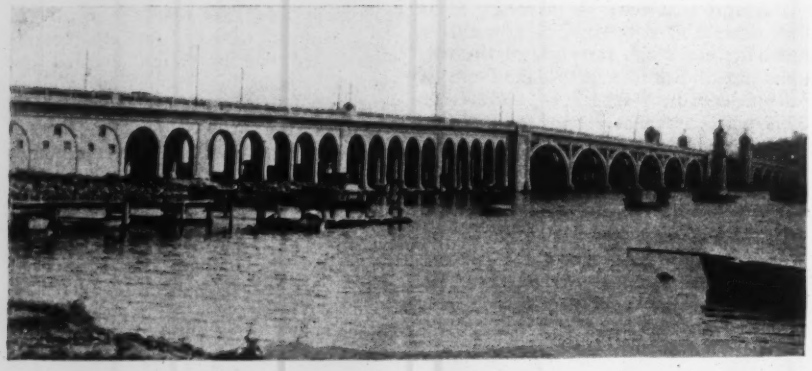
Fig. 1—Bridge across the Patapsco River at Hanover St., Baltimore, Md., which has recently undergone repairs to concrete parts damaged by expansion and moving fill.

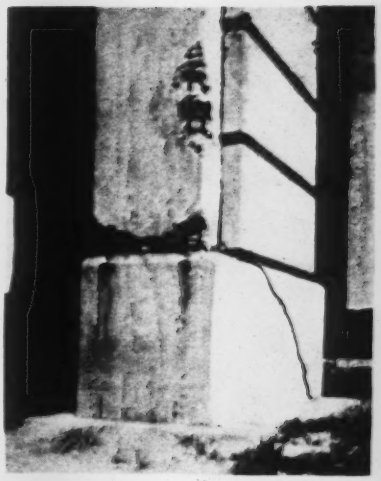
Fig. 4—Exterior column (K1, Fig. 3) of arcade approach, showing type of minor damage. Some columns had been virtually destroyed, and footings for others required reconstruction.

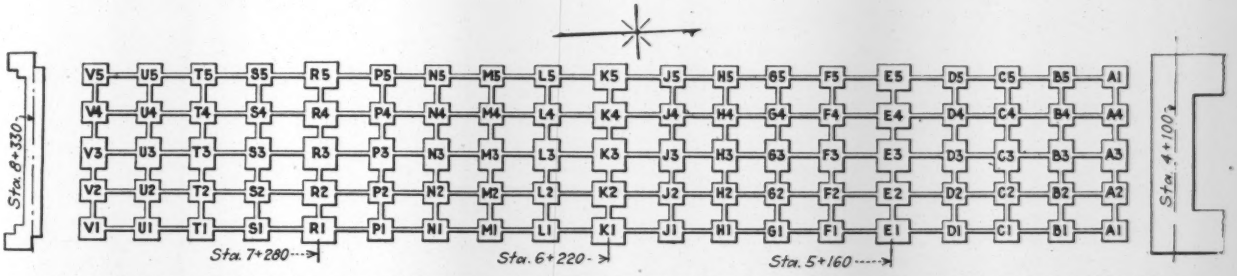
FIG. 3—COLUMN PLAN FOR ARCADE APPROACH, AND ITEMIZED DAMAGE SUSTAINED FROM FOUNDATION MOVEMENTS

V-5—This column or base has failed, and the base has been replaced with grillage incased in concrete. New concrete column is also in place.

E-3—The base of this column appears to be stable, but the side of the column near the base has cracked and the concrete has crumbled, exposing the steel.

E-1—This column at the expansion joint has numerous cracks at arch and one in the base. All ties appear to have failed, and base has moved S.E.

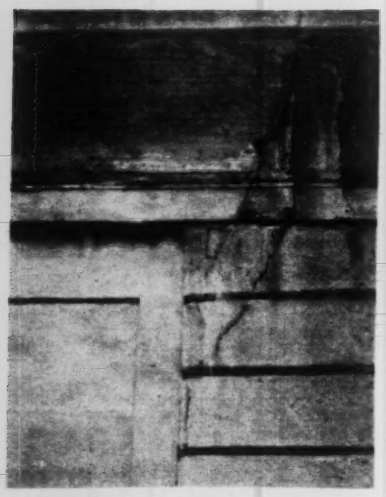
Fig. 5—Example of crack in retaining wall at an expansion joint.

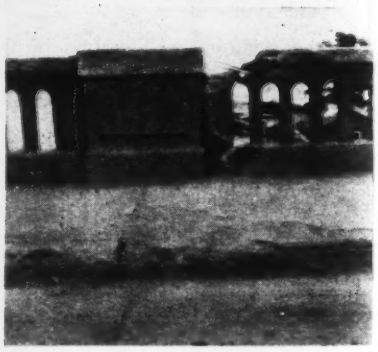
the cantilever ribs are concerned, is totally inadequate for the clearance at the curbs, sidewalk slabs and parapet walls. Apparently in some cases, instead of providing an inch or more of clearances for expansion in those portions of the structure, the faces of concrete were poured almost in contact, so that the damage to the curbs, sidewalks and parapet walls hereinafter described is traceable directly to the inadequacy of expansion provision made at the time of construction.

Fig. 7—Typical curb, sidewalk and parapet-wall damage resulting from faulty expansion-joint construction.

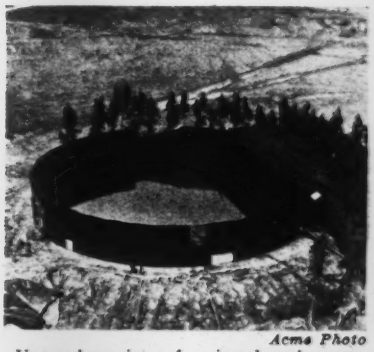
Upper three rings of a riveted steel water tank near Los Angeles were torn off. Damage presumably caused by surge of water as quake rocked the tank.
